Manhole Inspection Summary

Manhole # S13OO1003MH

Insp Date: **11/29/06 8:59 AM**

Location Address: **2811 WOODLAND AVE**

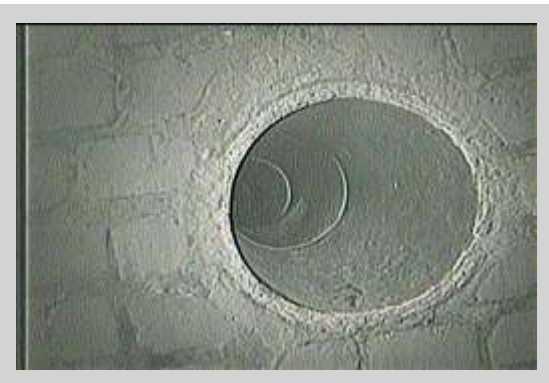
8 in. Circular Gravity Sewer Pipe In @ 6 O'Clock

Pipe Material: **Clay** ☐ Pipe Lined

Invert Depth: **8.62** (ft.) Flow Characteristics: **Slow**

Deposits: ☒ None ☐ Mud ☐ Sludge ☐ Debris ☐ Grease

Infiltration: **None** Pipe Seal Cond: **Unknown**

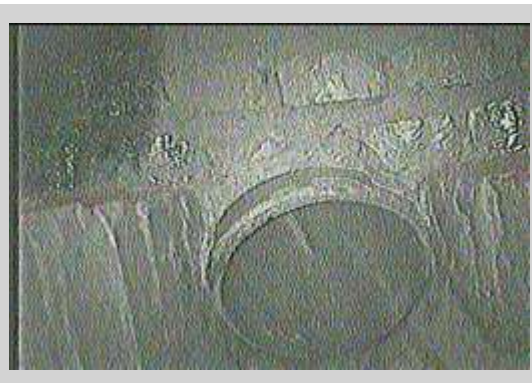
Drop In @ 6 O'Clock

Drop: **Outside** Rod and Bar

Angled: **Yes** Reading: **10.10** (ft.)

Inv Depth: **11.10** (ft.)

Drop Condition: **Open**

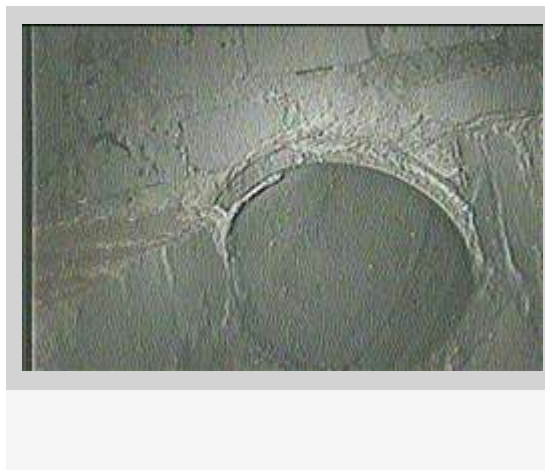
Drop In @ 8 O'Clock

Pipe Material: **Clay**

Infiltration: **Evidence**

Drop Condition: **Open**
